Parkfairfax Using New Erosion Control Pipes

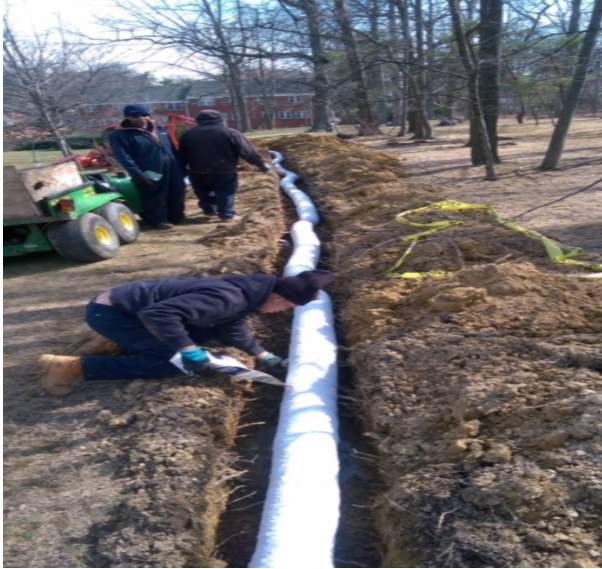
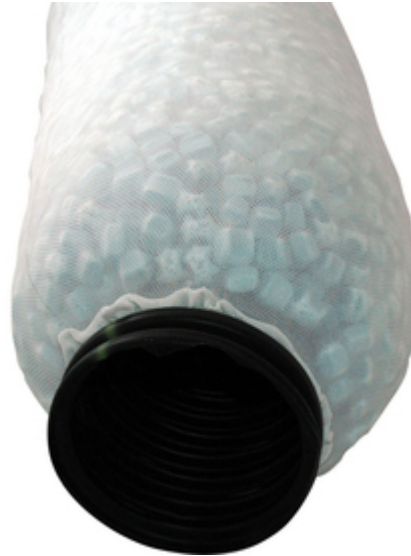
This photo shows staff installing 4" corrugated pipe in the hillside of the rear of building 206, 3108 Martha Custis Drive. Note the covering that surrounds the pipe. This is actually a sock filled with polystyrene aggregate (packing peanuts) wrapped with a filter fabric. This is a more robust technique than the old standard corrugated pipe as it actually gathers more water and channels it in the pipe to be carried away from buildings. This new line will be tied directly into an existing storm line. This method will also allow us to reseed or sod to restore washed out grass areas.

In the coming weeks we will begin to address several other areas on the property using this and other new techniques to remedy numerous water issues that have plagued Parkfairfax for years. Staff is energized and committed to these new methods and looking forward to great results.
